INDOOR AIR QUALITY ASSESSMENT

Minnechaug Regional High School
621 Main Street
Wilbraham, Massachusetts

Prepared by:
Massachusetts Department of Public Health
Center for Environmental Health
Emergency Response/Indoor Air Quality Program
February 2007

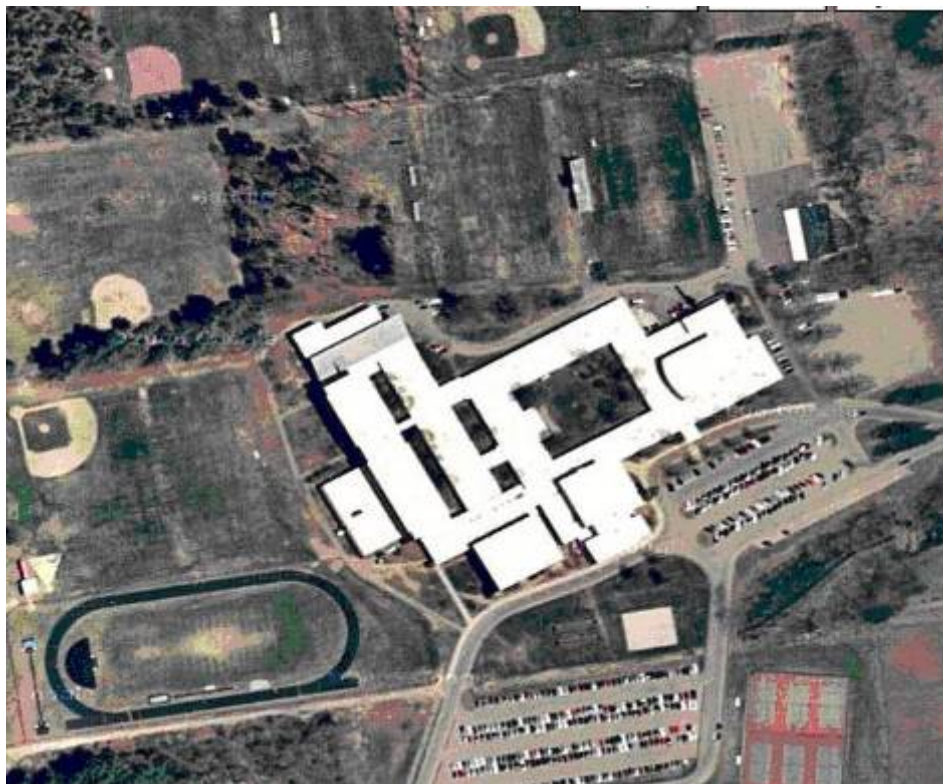
Picture 1

The MRHS is a multi-wing red brick building constructed in 1958. A single, three story wing contains classrooms (Picture 1). A gymnasium, pool, auditorium, shops and administrative offices are located in a series of one story wings. Windows were openable throughout the MRHS.

Aerial View of MRHS
